Heliscreen® CSO Retrofit Beneath Main Road

Project Profile

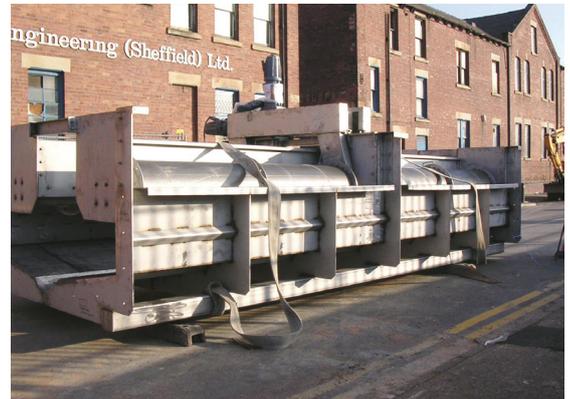
Carlisle Street Heliscreen® awaiting installation.

To upgrade this to a positive screening method, at an economical cost, Yorkshire Water installed twin patented Heliscreen®s in double high-sided weirs. Both units were supplied with bespoke stainless steel flow channels which enabled complete mechanical installation within one day with minimal civil work.

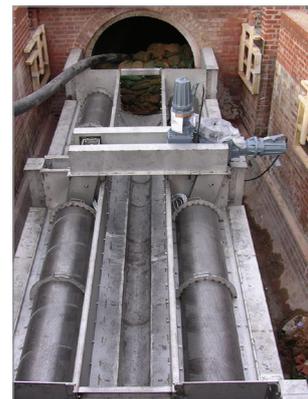
Carlisle Street Heliscreen® installed in the chamber.

Hydro International's patented Heliscreen® is a self-cleansing, low head loss screening device that protects CSO outfalls by retaining all matter greater than 6 mm (in 2 directions) in the foul continuation flow to the treatment. The Heliscreen® works effectively even in totally flooded chambers with surcharged outflow pipes.
